# Seismic Imaging as a Means to Investigate Abandoned Underground Mines

Interstate Technical Group on Abandoned Underground Mines

April 23, 2004

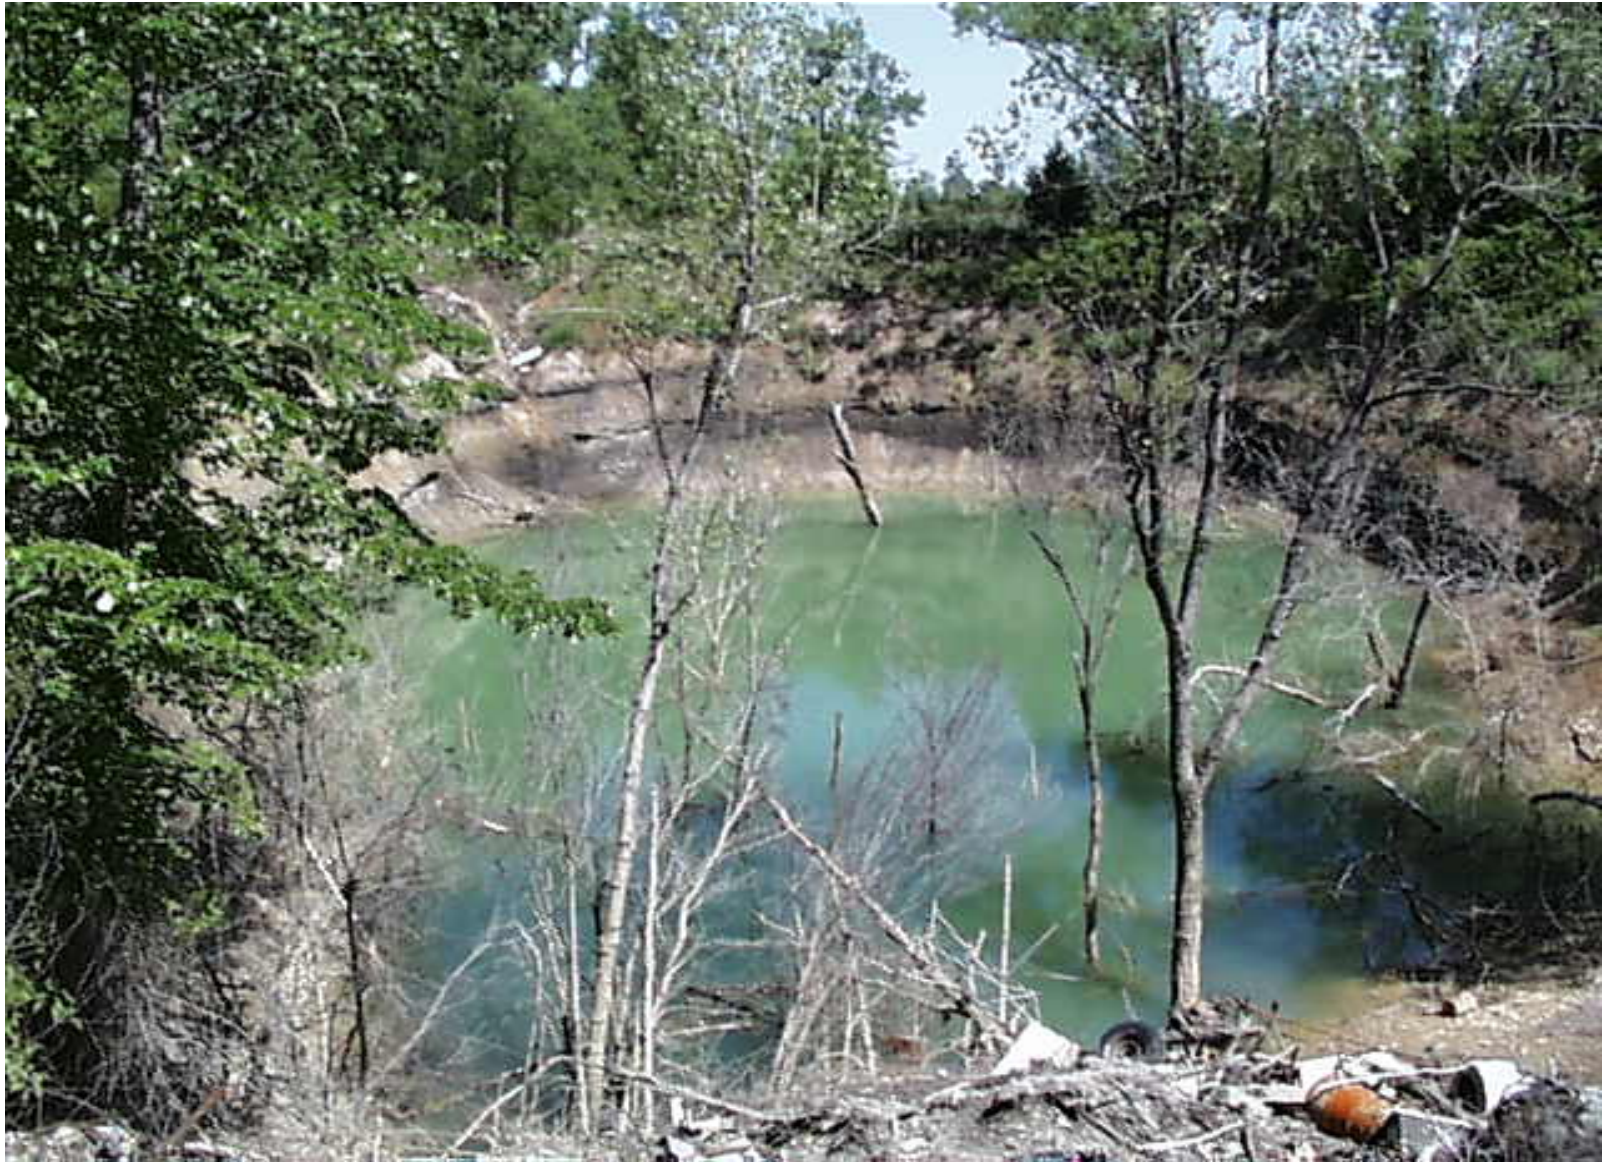
Photograph No. 19

Title: *Subsidence: Approx. 300 Feet East of US-69 at  
Kansas-Oklahoma Border*

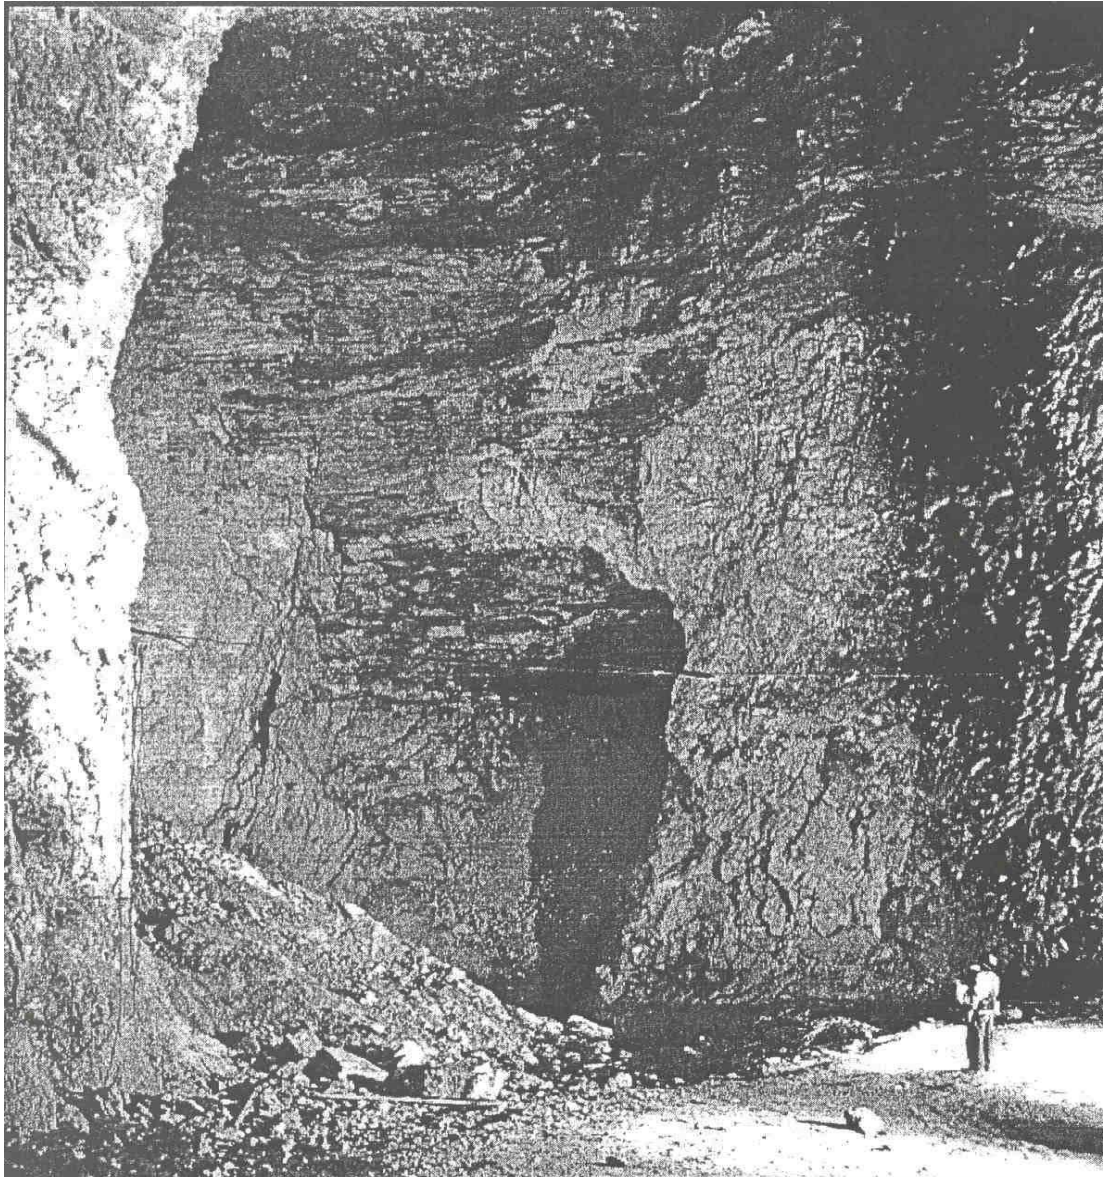
Photograph No. 9

Title: *Mine Cavern Believed Similar to NSA Panels 5 & 6*

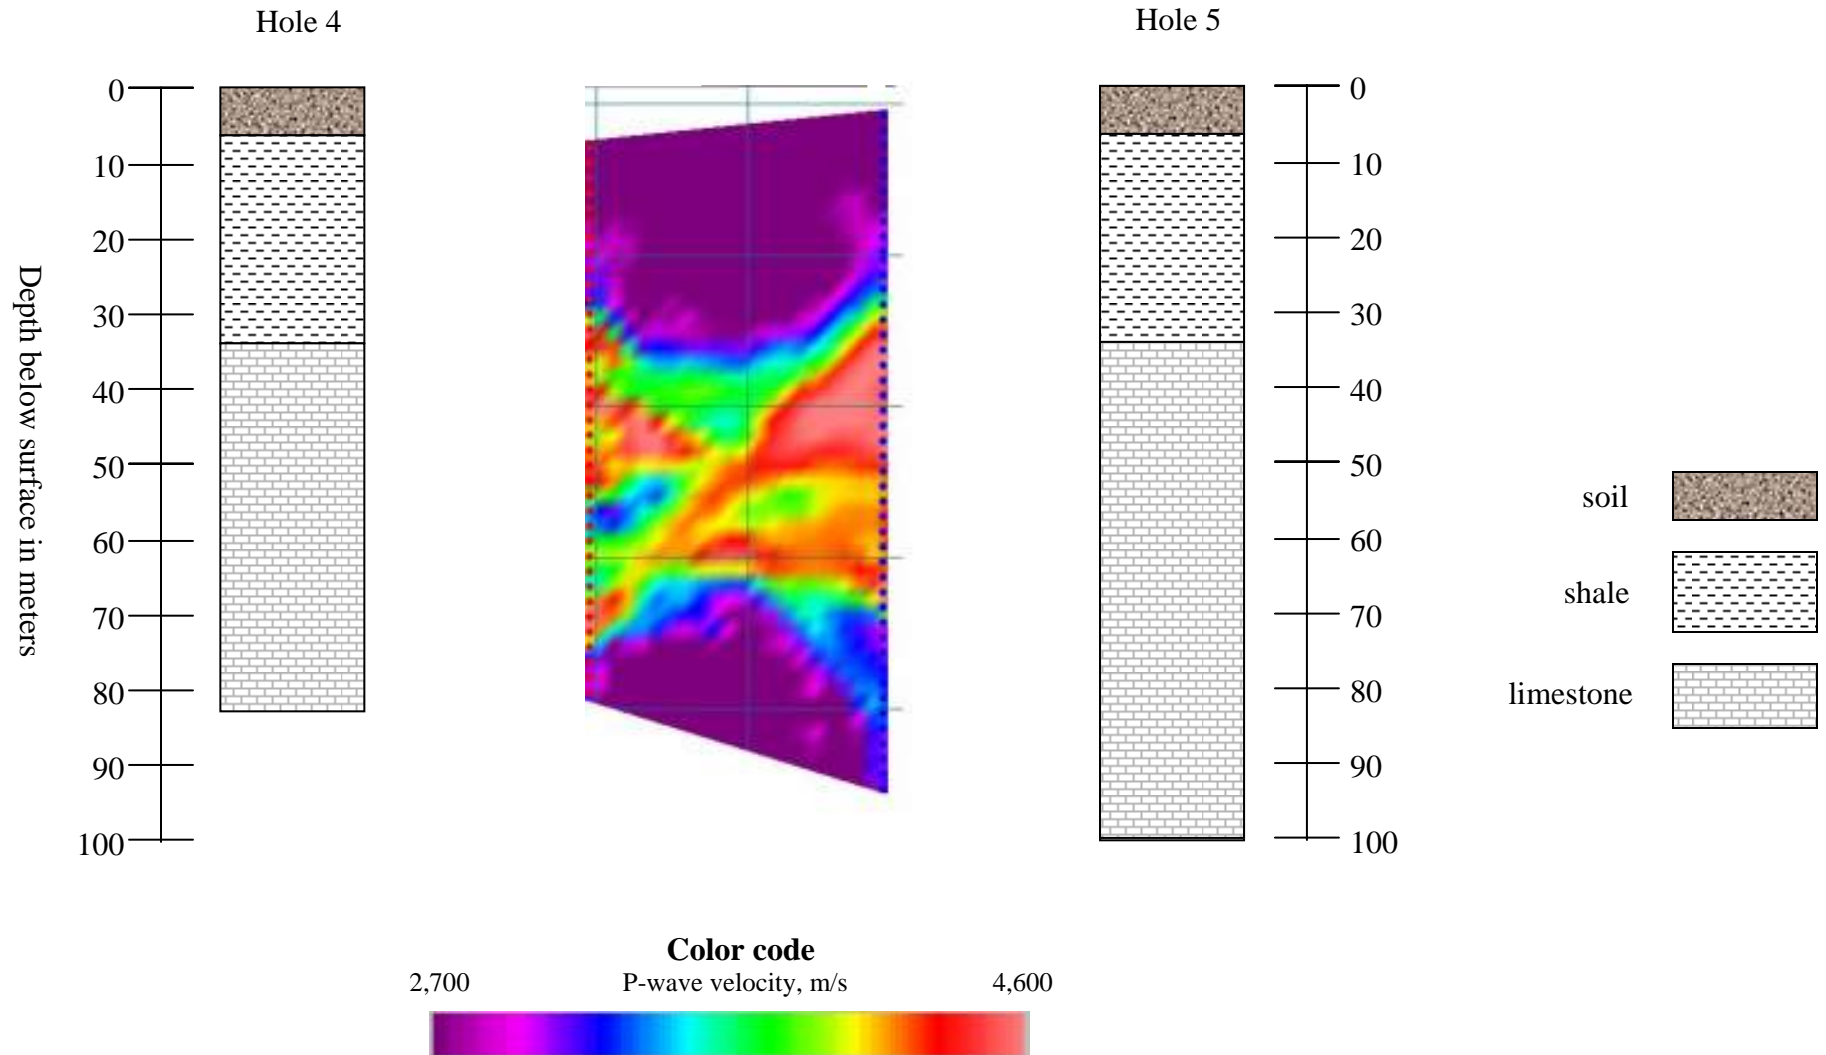
**Approximately 25 m of competent limestone beneath the shale is indicated, but a large void, likely caused by mine roof failure migrating toward the surface is present.**

- To summarize the tomography results:
  - Only Panel 4-5 clearly indicated a void that appears to be related to failure of the mine roof
  - Panel 9-10 shows the existence of voids that may be mining-related, but are more likely naturally occurring
  - Limestone of varying degrees of competence exists throughout the Panels
    - Usually of significant thickness (20m to 50m)

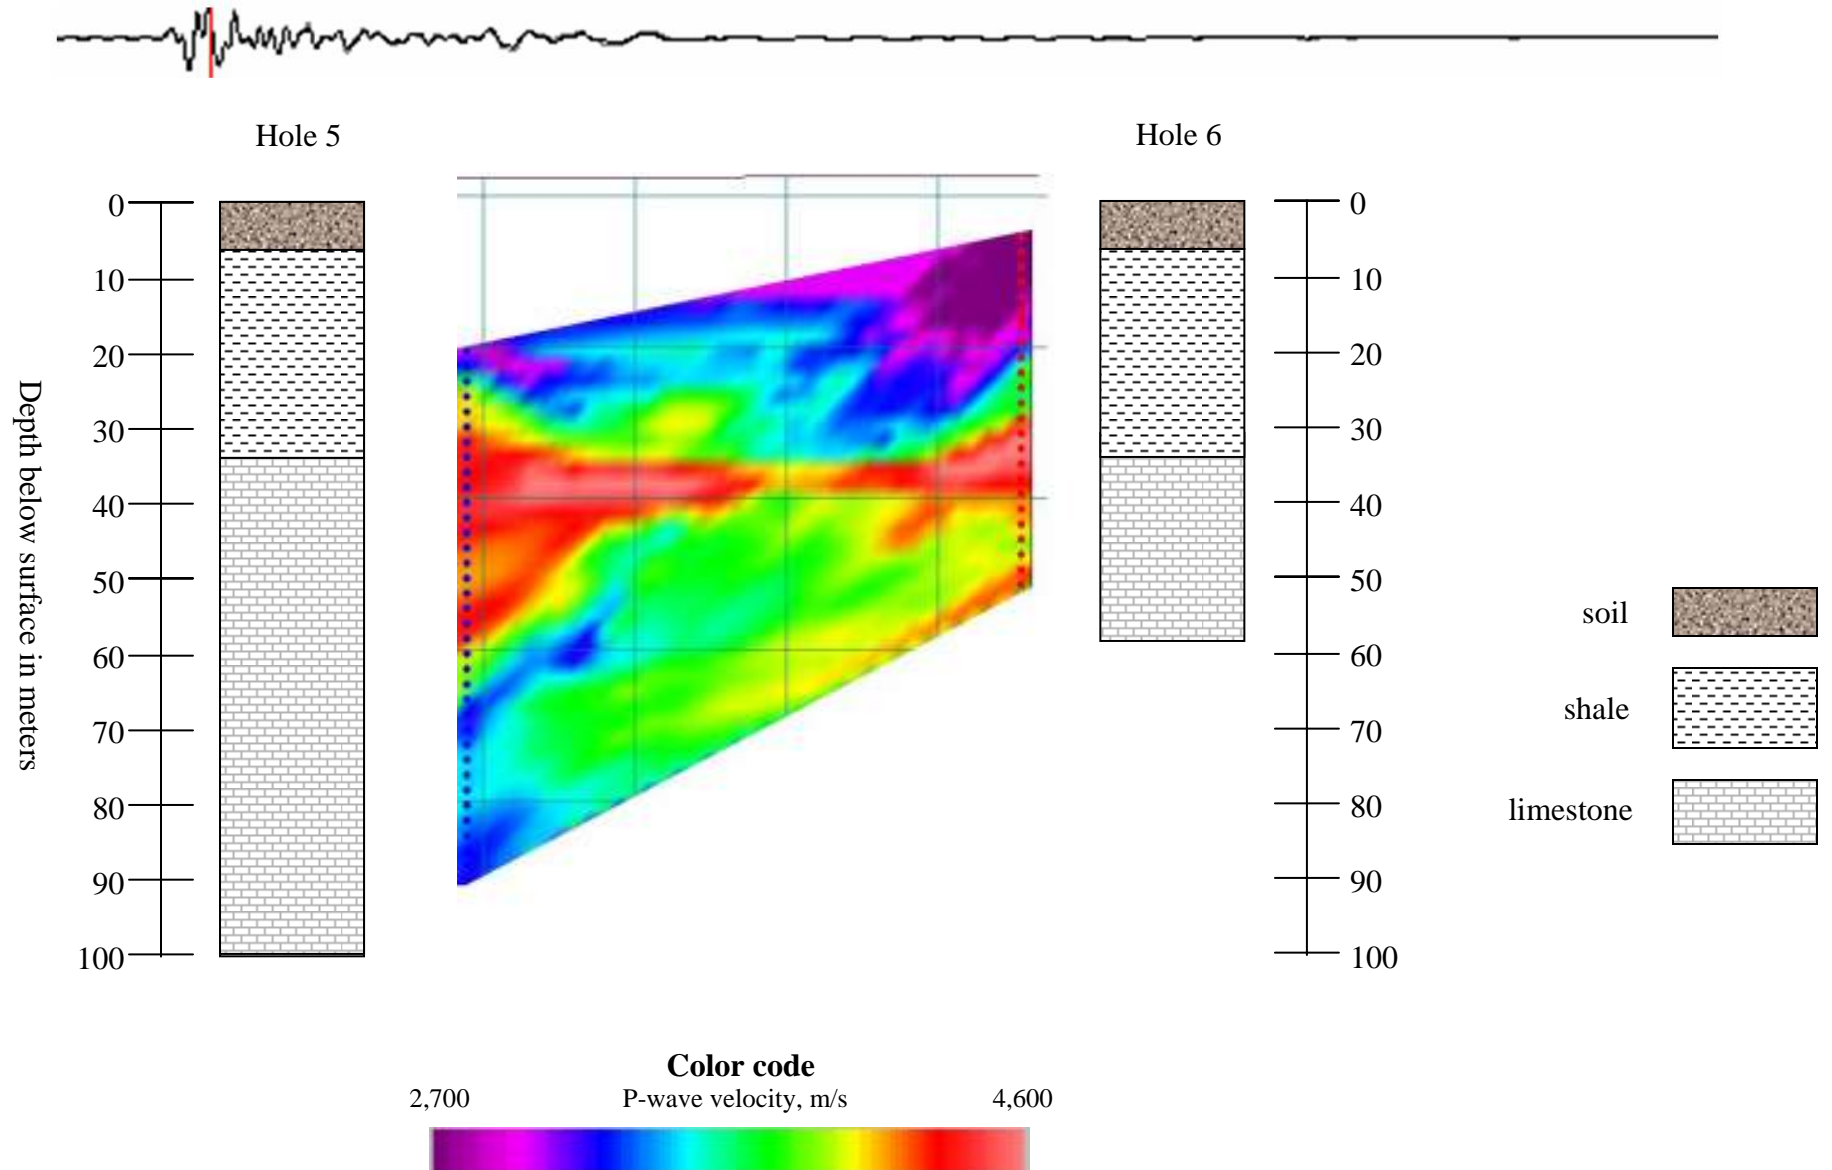
The tomogram shows that only a thin (~5 m) layer of competent limestone exists between the mine roof and the shale. The remaining limestone appears to be less competent. There is no indication that roof failure has migrated up through this weaker limestone layer, but the potential for roof failure migration is likely higher in this area because of the reduced limestone competence.

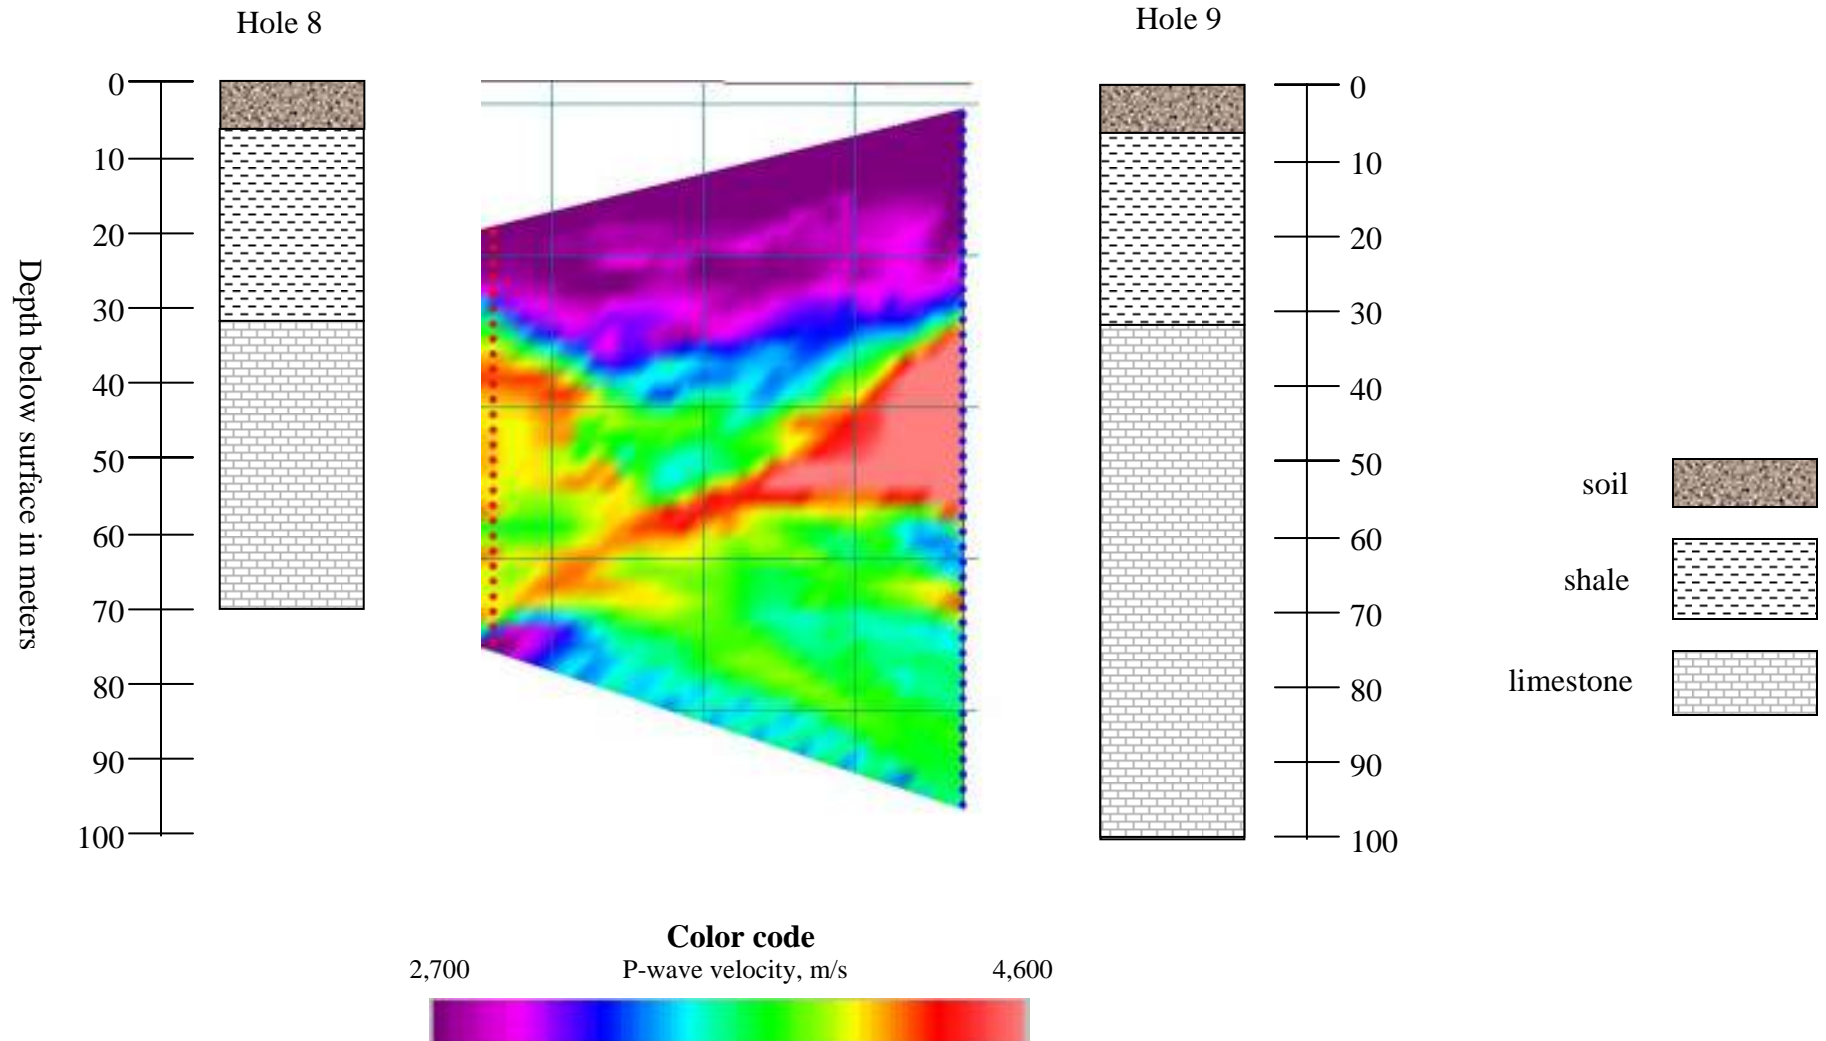
Competent limestone is evident (~30 m near Boring #8 and ~70 m near Boring #9), although velocities in the limestone are markedly lower than in previous panels. This is probably due to numerous small voids or brecciation within the limestone, rather than to roof failure migration.

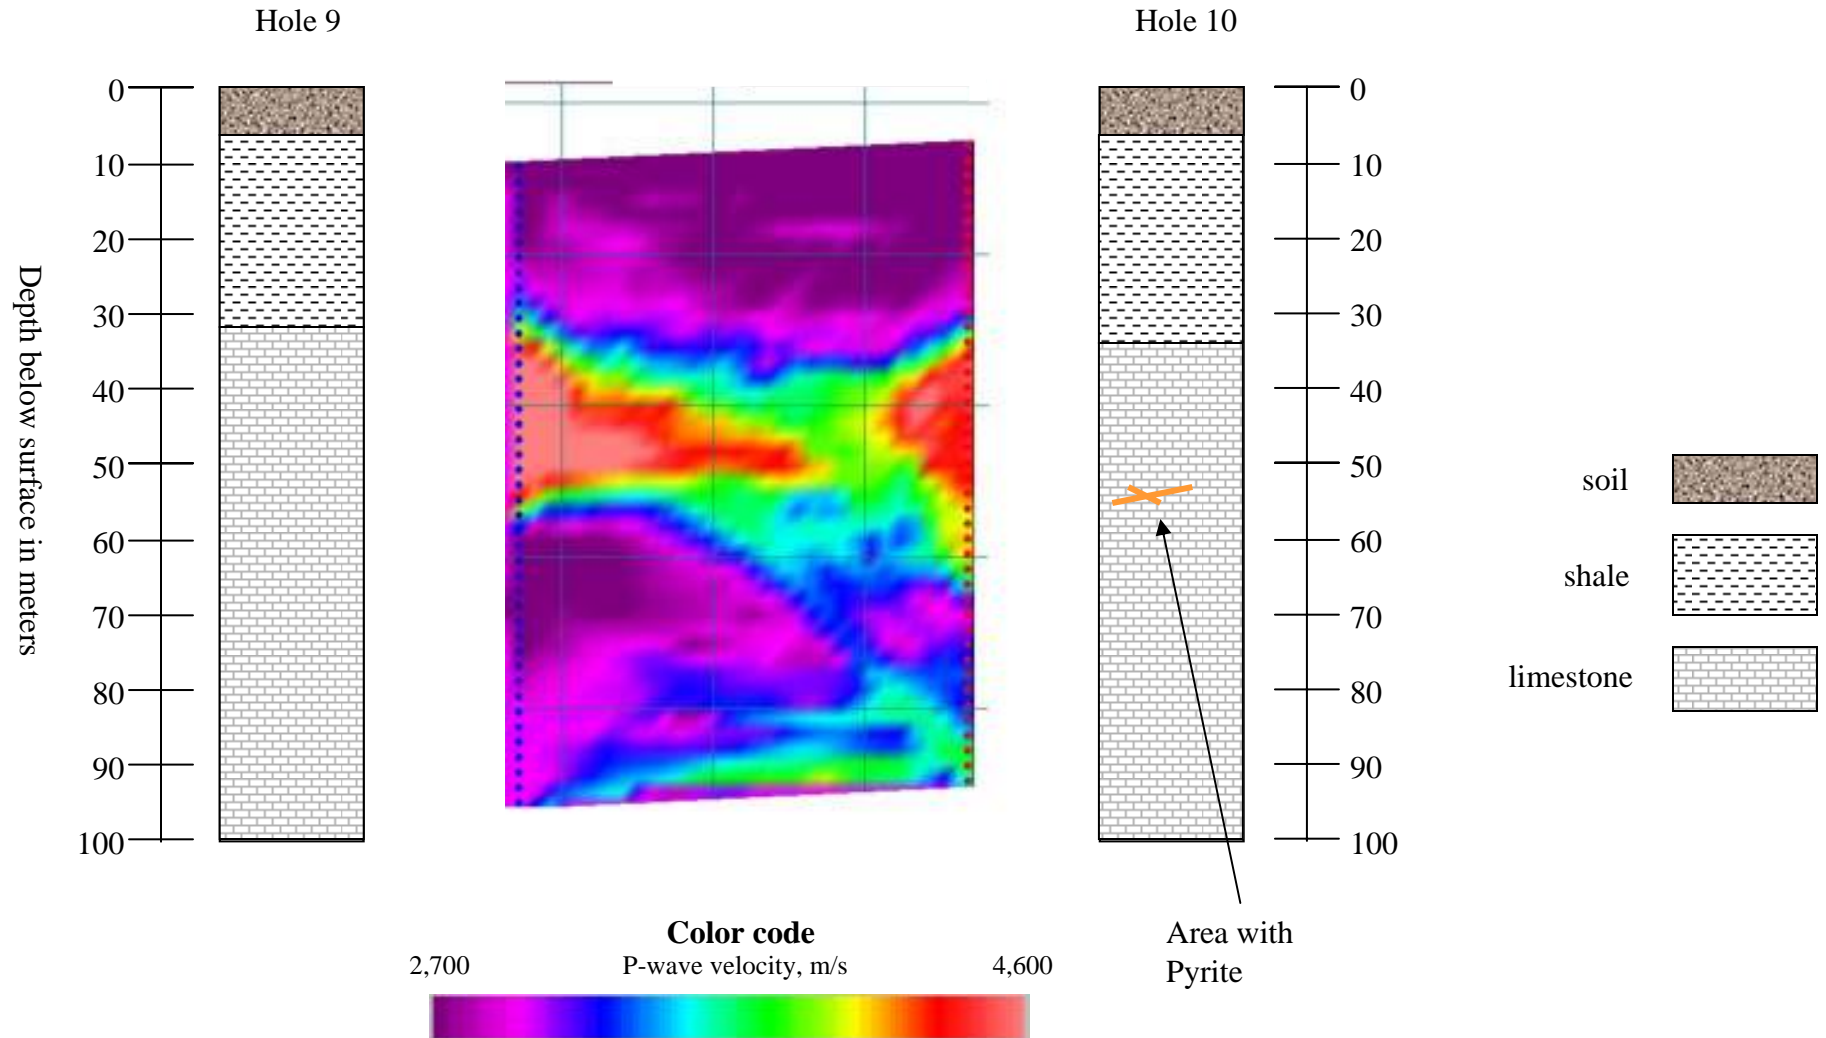
**Tomogram indicates a large void between Boring #9 and Boring #10, closer to Boring #9. The drill log indicated water in this area, but no indication of a mine void. This could possibly be a breccia zone. About 20 m of competent limestone separates the void and the shale.**

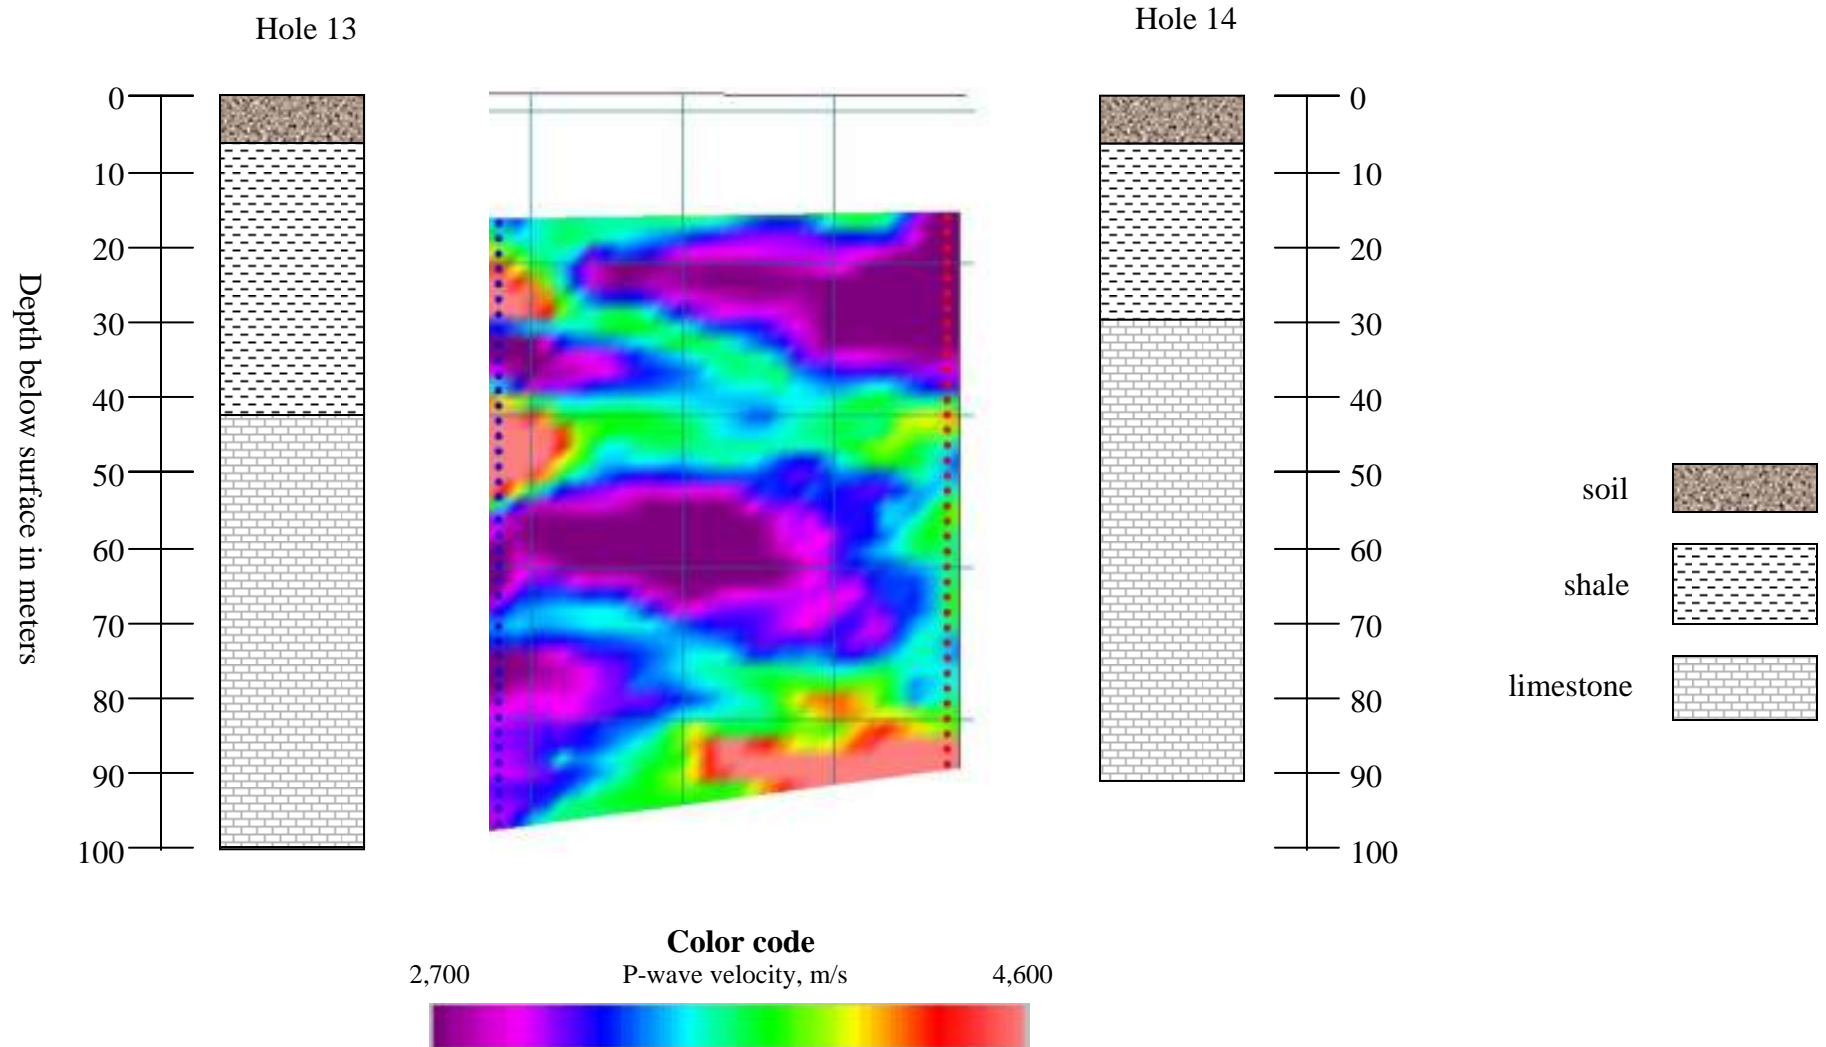
**Apparent voids exist between Borings #13 and #14, closer to Boring #13.  
Because of their location, it is surmised that these voids are naturally-occurring rather than mining-related.**
